Revision extensor mechanism reconstruction using Marlex Mesh in the setting of proximal tibial bone deficiency: The Tantalum Clamshell Technique.

Stavros Niarchos Foundation
Complex Joint Reconstruction Center

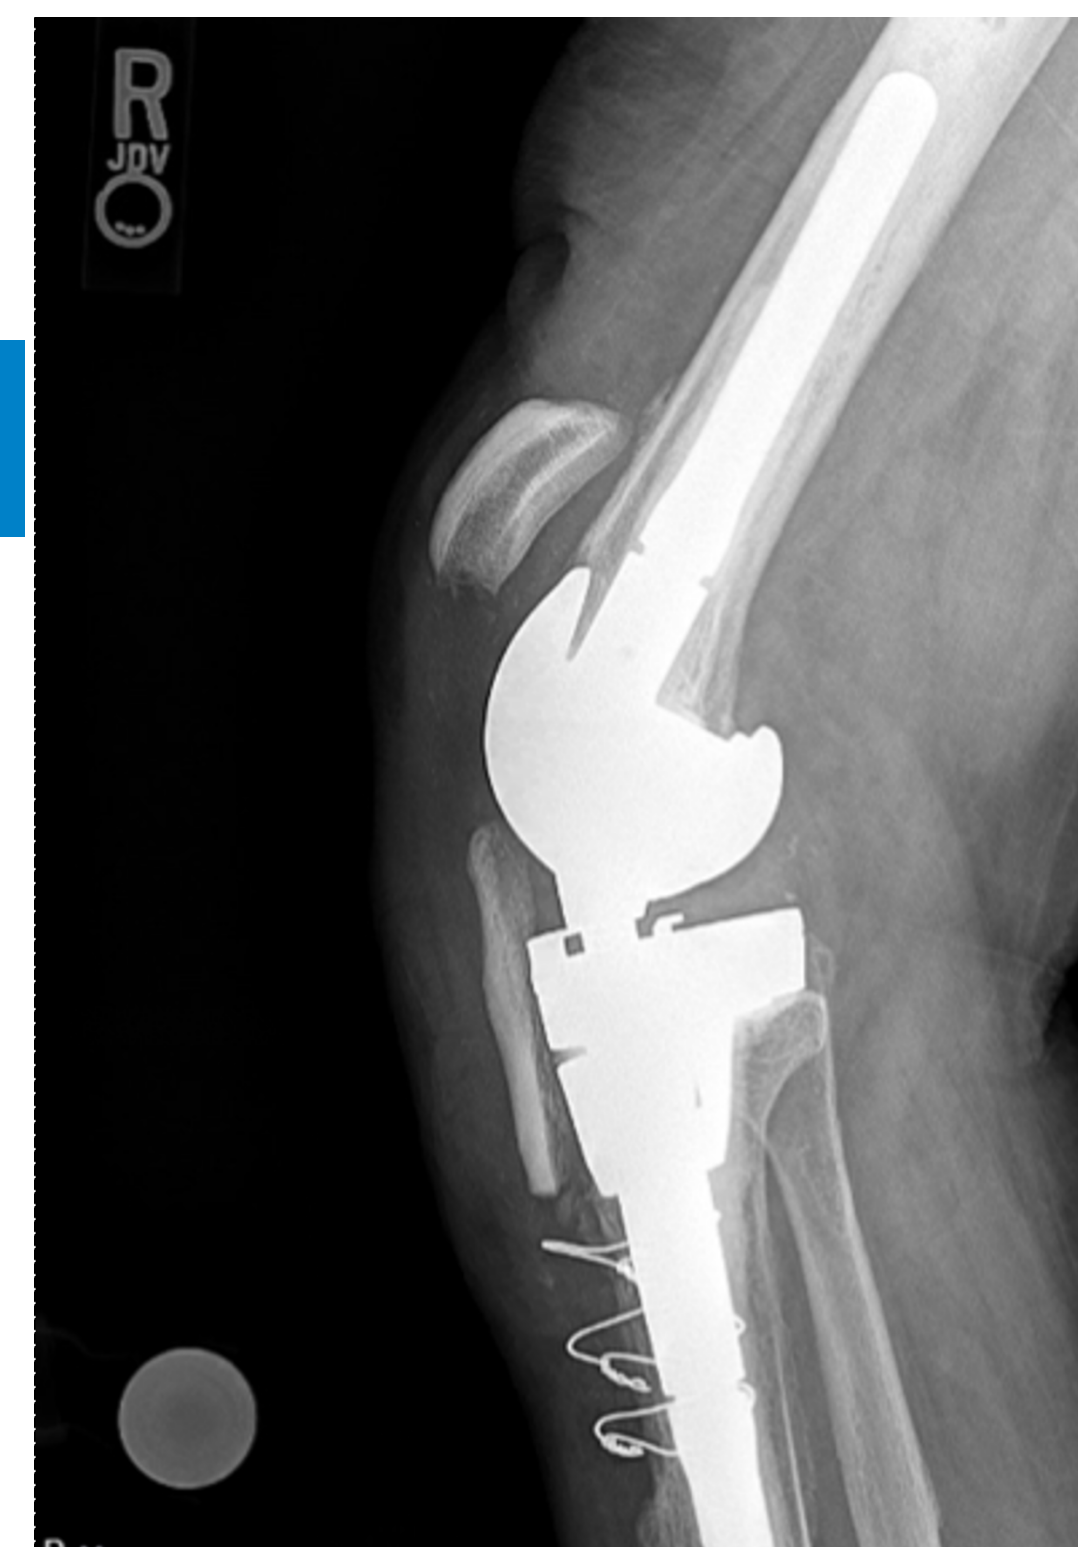
The tibial aspect of the allograft superiorly displaced, 6 months after the procedure

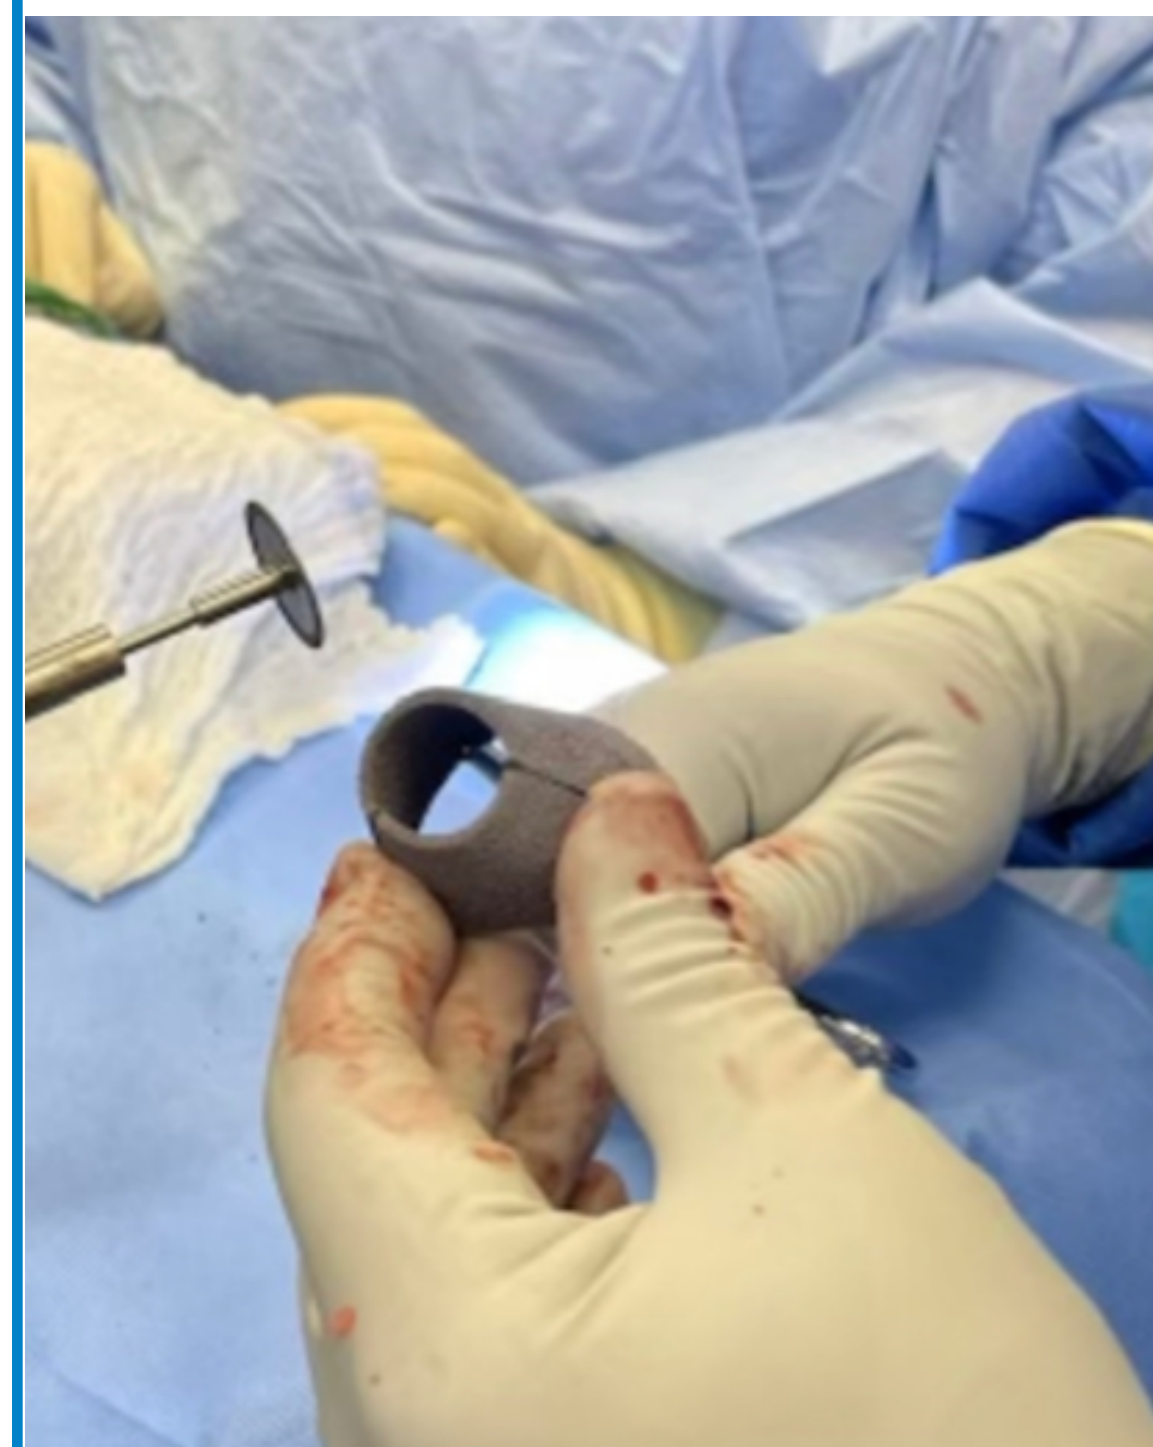
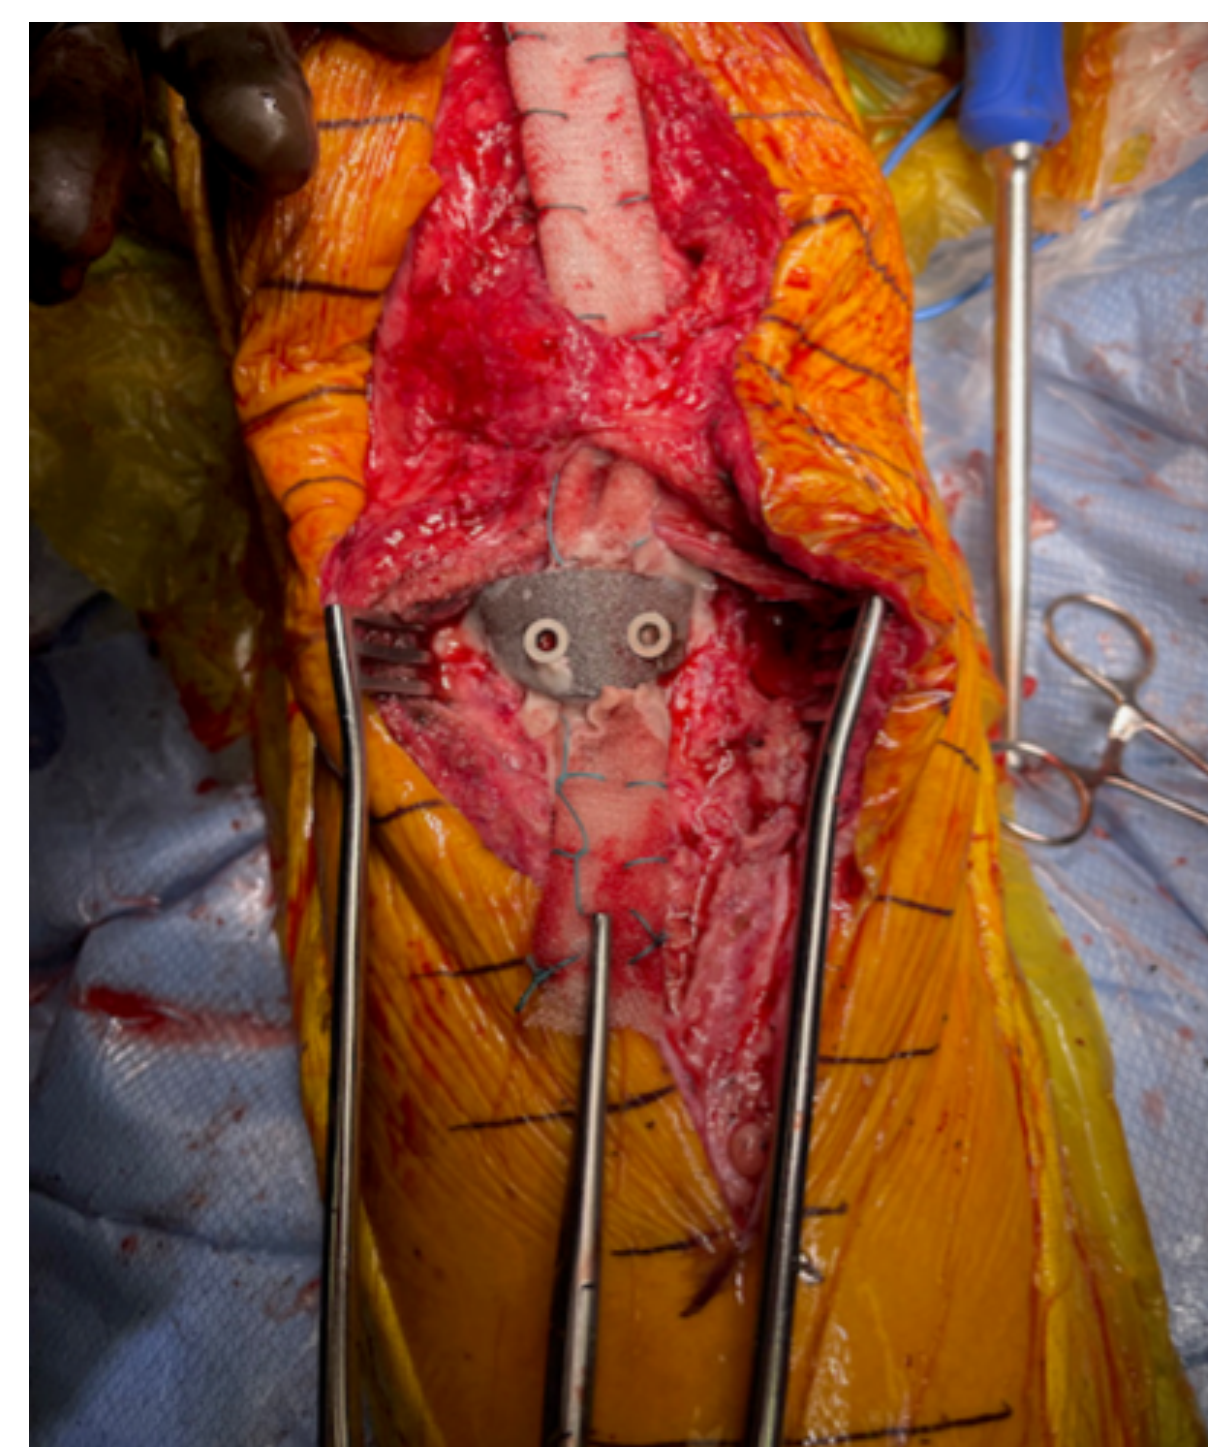
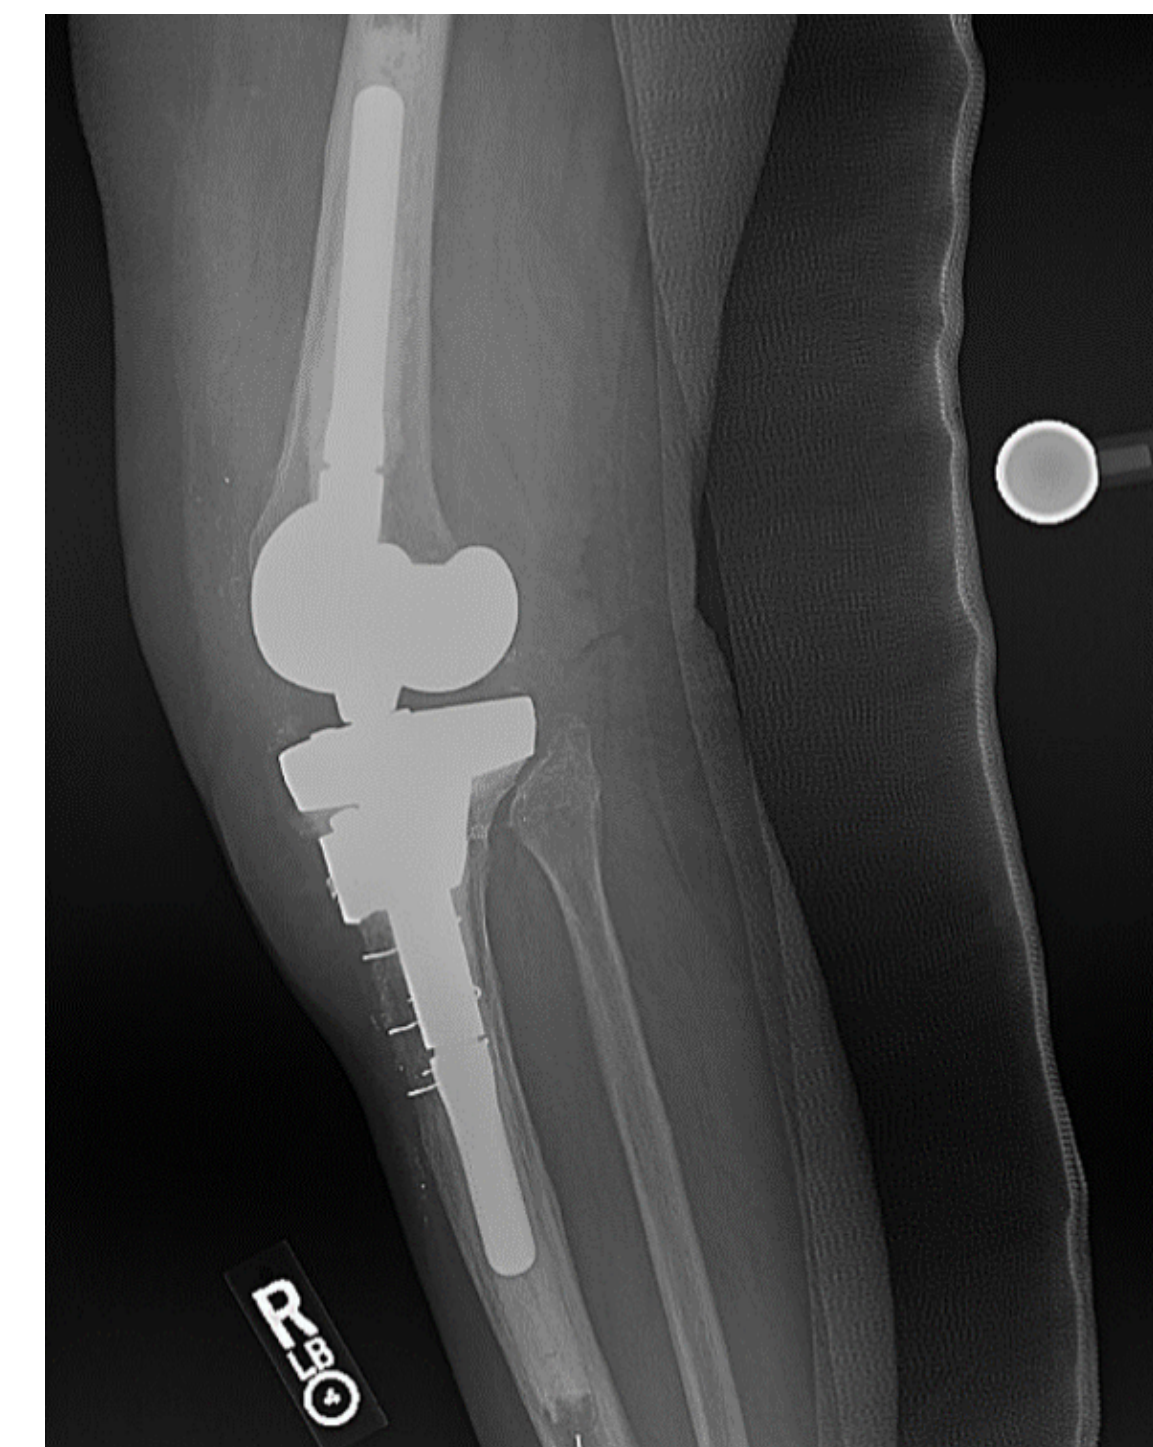
The surgical procedure involved the removal of a non-viable allograft from the knee joint and the creation of a custom trabecular metal (TM) clamshell construct with a Marlex mesh graft in between the two TM implants. A TM tibial cone was selected that would provide good anterior coverage of the deficient proximal tibia and wrap around the ingrown TM cone. The borders of the TM cone that needed to contact the peripheral host tibial cone were marked. Then, the TM cone was customized using a metal cutting diamond wheel until its outer shape closely replicated the convex anterior surface of the deficient tibia. The Marlex mesh was cemented between the existing implant and the customized TM cone, and the construct was secured in place with two cancellous screws. The mesh was tunneled between soft tissue to prevent contact with the implant and rotated scar tissue was interposed to prevent abrasion of the mesh on the implant surfaces.

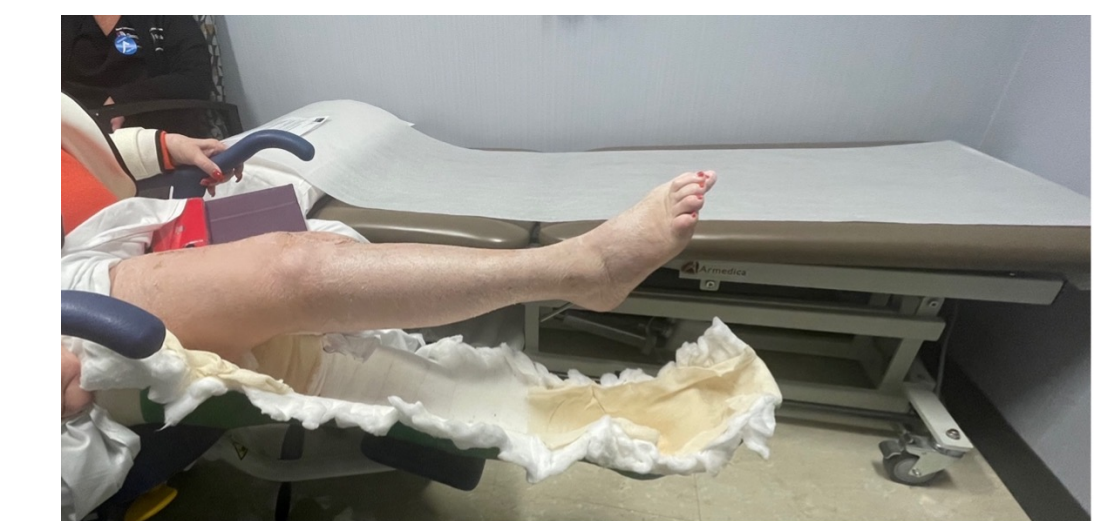
- In a follow-up 12 weeks after the operation, the patient reported an overall feeling of wellness and denied any pain or swelling in the knee. Her incision had healed well, and there were no signs of wound complications. The knee was in full extension with a 1° extension lag.
